City of San Diego
FY15 Facility Condition Assessment Report for:
Facility # 000008 Office. City Operations Building. COB. Downtown

FACILITY EXECUTIVE SUMMARY

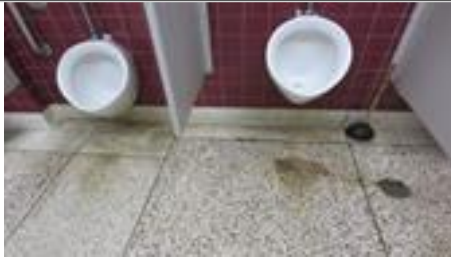
| DEFICIENCY REPORT – Building Only | | | | | | | |
|---|---|---|---|---|---|---|---|
| 2015 | Recommended | Floor Finishes | Replace | | 1970 System | Capital | \$16,246,752 |

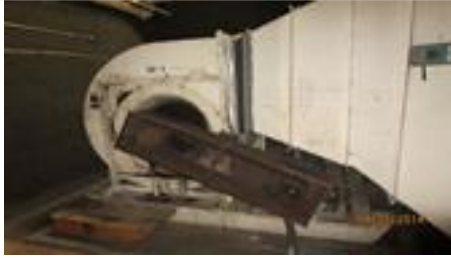
| DEFICIENCY REPORT – Building Only | | | | | | | |
|---|---|---|---|---|---|---|---|
| 2015 | Necessary | Distribution Systems | Replace | | 1970 System | Capital | \$15,383,765 |

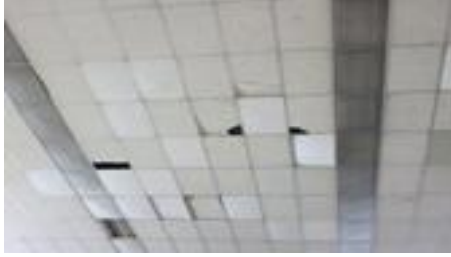
| DEFICIENCY REPORT – Building Only | | | | | | | |
|---|---|---|---|---|---|---|---|
| 2015 | Recommended | Ceiling Finishes | Replace | | 1970 System | Capital | \$13,641,099 |

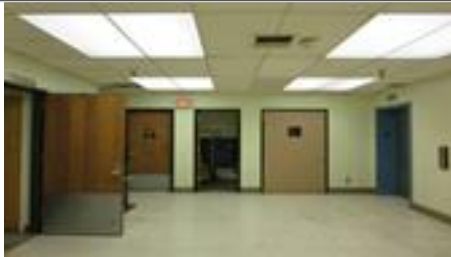
| DEFICIENCY REPORT – Building Only | | | | | | | |
|---|---|---|---|---|---|---|---|
| 2015 | Recommended | Interior Doors | Replace | | 1970 System | Capital | \$12,047,665 |

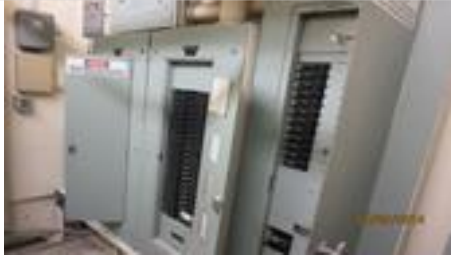
| DEFICIENCY REPORT – Building Only | | | | | | | |
|---|---|---|---|---|---|---|---|
| 2015 | Potentially Critical | Electrical Service Distribution | Replace | | 1970 System | Capital | \$8,975,392 |

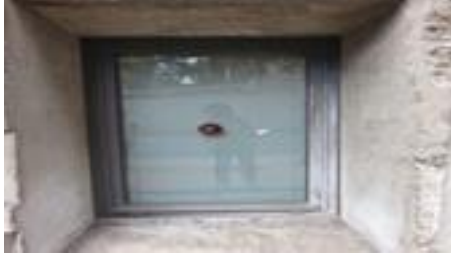
| DEFICIENCY REPORT – Building Only | | | | | | | |
|---|---|---|---|---|---|---|---|
| 2015 | Necessary | Exterior Windows | Replace | | 1970 System | Capital | \$8,226,037 |

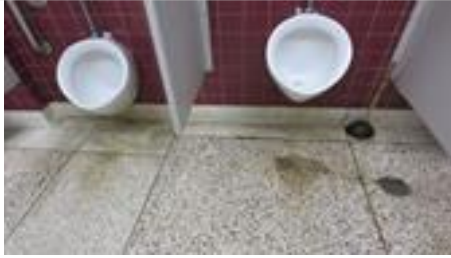
| DEFICIENCY REPORT – Building Only | | | | | | | |
|---|---|---|---|---|---|---|---|
| 2015 | Necessary | Plumbing Fixtures | Replace | | 1970 System | Capital | \$6,717,483 |

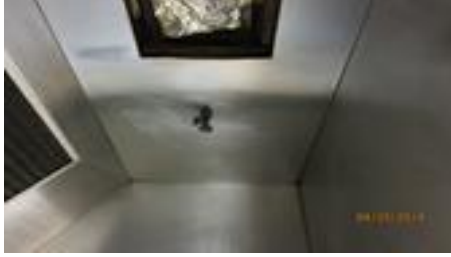
| DEFICIENCY REPORT – Building Only | | | | | | | |
|---|---|---|---|---|---|---|---|
| 2015 | Critical | Sprinklers | Replace | | 1970 System | Capital | \$2,710,450 |

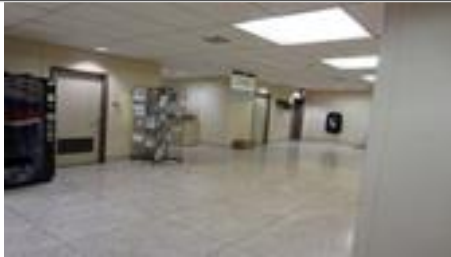
| DEFICIENCY REPORT – Building Only | | | | | | | |
|---|---|---|---|---|---|---|---|
| 2015 | Recommended | Wall Finishes | Replace | | 1970 System | Capital | \$2,289,663 |

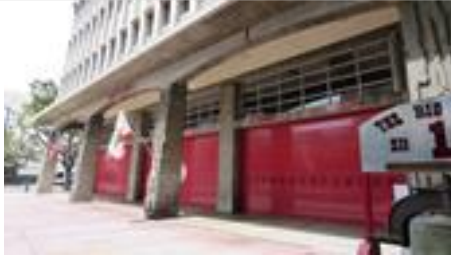
| DEFICIENCY REPORT – Building Only | | | | | | | |
|---|---|---|---|---|---|---|---|
| 2015 | Necessary | Exterior Doors | Replace | | 1970 System | Capital | \$2,006,874 |

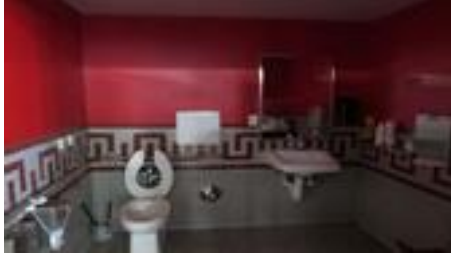
| DEFICIENCY REPORT – Building Only | | | | | | | |
|---|---|---|---|---|---|---|---|
| 2015 | Recommended | Sanitary Waste | Replace | | 1970 System | Capital | \$1,325,604 |

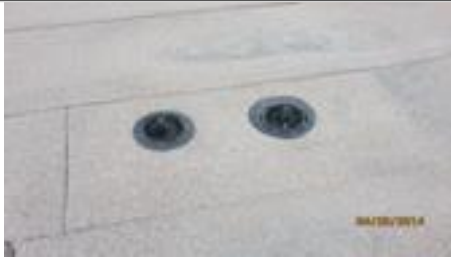
| DEFICIENCY REPORT – Building Only | | | | | | | |
|---|---|---|---|---|---|---|---|
| 2015 | Necessary | Rain Water Drainage | Replace | | 1970 System | Capital | \$1,205,669 |

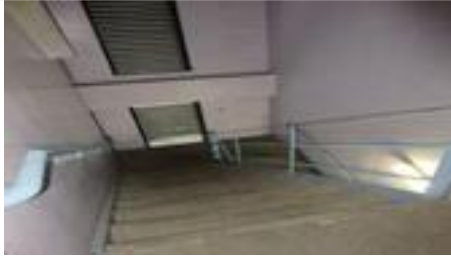
| DEFICIENCY REPORT – Building Only | | | | | | | |
|---|---|---|---|---|---|---|---|
| 2015 | Recommended | Stair Finishes | Replace | | 1970 System | Capital | \$937,392 |

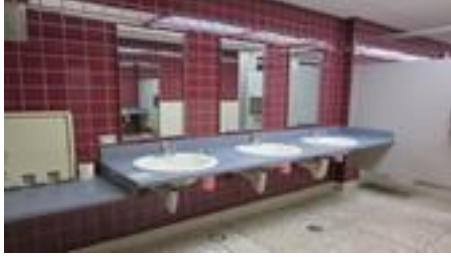
| DEFICIENCY REPORT – Building Only | | | | | | | |
|---|---|---|---|---|---|---|---|
| 2015 | Potentially Critical | Domestic Water Distribution | Replace | | 1970 System | Capital | \$858,487 |

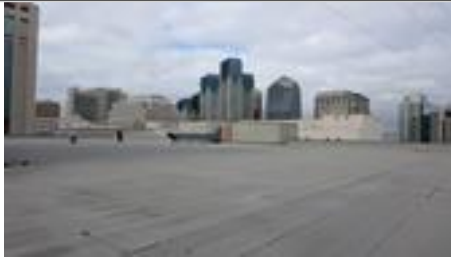
| DEFICIENCY REPORT – Building Only | | | | | | | |
|---|---|---|---|---|--|---|---|
| 2015 | Critical | Roof Coverings | Replace | | 1970 System | Capital | \$824,043 |

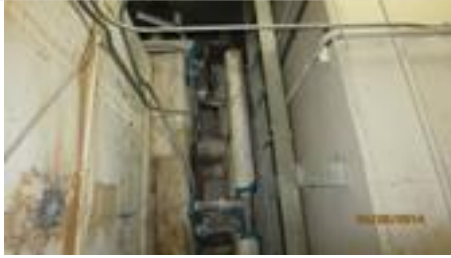
| DEFICIENCY REPORT – Building Only | | | | | | | |
|---|---|---|---|---|--|---|---|
| 2015 | Necessary | Distribution Systems | Replace | | Floor: Roof 1 Room: Penthouse ID: Type: Air Handling Units | Capital | \$491,751 |

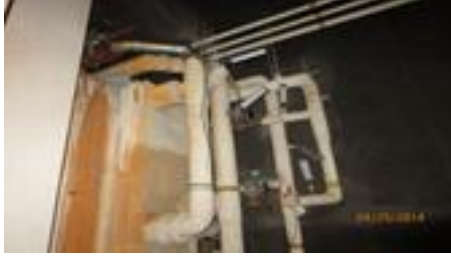
| DEFICIENCY REPORT – Building Only | | | | | | | |
|---|---|---|---|---|--|---|---|
| 2015 | Necessary | Distribution Systems | Replace | | Floor: Roof 1 Room: Penthouse ID: Type: Air Handling Units | Capital | \$491,751 |

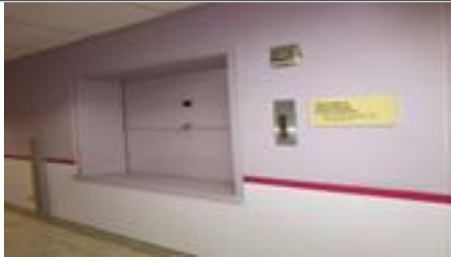
| DEFICIENCY REPORT – Building Only | | | | | | | |
|---|---|---|---|---|---|---|---|
| 2015 | Necessary | Other Conveying Systems | Replace | | 1970 System | Capital | \$422,931 |

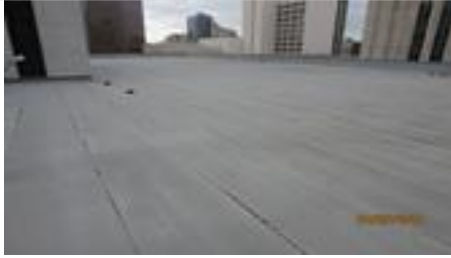
| DEFICIENCY REPORT – Building Only | | | | | | | |
|---|---|---|---|---|---|---|---|
| 2015 | Critical | Roof Coverings | Replace | | Floor: Roof 2 Room: Roof ID: Type: Modified Bitumen | Capital | \$320,269 |

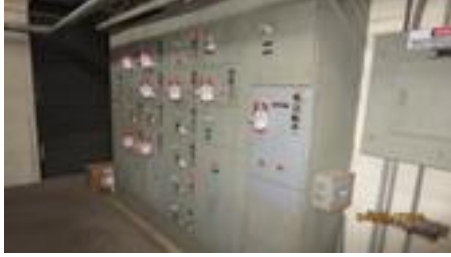
| DEFICIENCY REPORT – Building Only | | | | | | | |
|---|---|---|---|---|---|---|---|
| 2015 | Potentially Critical | Electrical Service Distribution | Replace | | Floor: Roof 1 Room: Penthouse ID: Type: Motor Control Centers | Capital | \$259,373 |

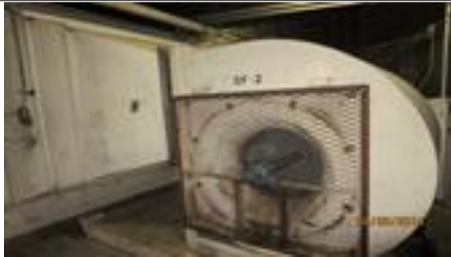
| DEFICIENCY REPORT – Building Only | | | | | | | |
|---|---|---|---|---|---|---|---|
| 2015 | Necessary | Distribution Systems | Replace | | Floor: Roof 1 Room: Penthouse ID: U-696253 Type: Exhaust Fans | Capital | \$143,900 |

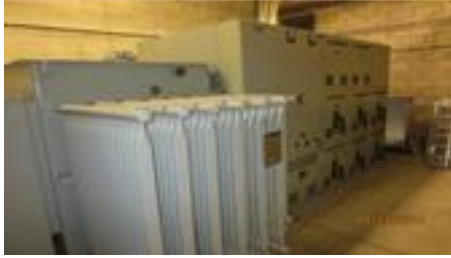
| DEFICIENCY REPORT – Building Only | | | | | | | |
|---|---|---|---|---|---|---|---|
| 2015 | Potentially Critical | Electrical Service Distribution | Replace | | Floor: B1 Room: Main Elec Room ID: SNE25574-1F Type: Electrical Panel | Capital | \$113,845 |

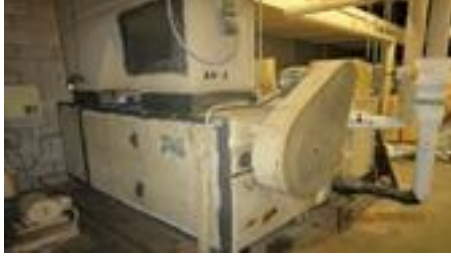
| DEFICIENCY REPORT – Building Only | | | | | | | |
|---|---|---|---|---|---|---|---|
| 2015 | Necessary | Distribution Systems | Replace | | Floor: B1 Room: Mech Room ID: Type: Air Handling Units | Capital | \$108,407 |

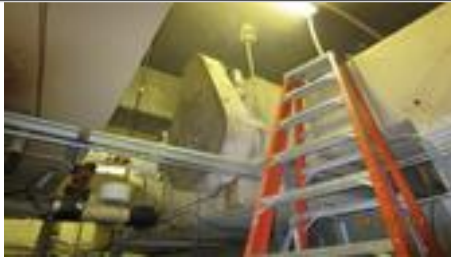
| DEFICIENCY REPORT – Building Only | | | | | | | |
|---|---|---|---|---|---|---|---|
| 2015 | Necessary | Distribution Systems | Replace | | Floor: B1 Room: Mech Room 2 ID: Type: Air Handling Units | Capital | \$108,407 |

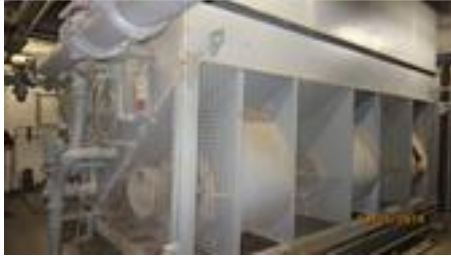
| DEFICIENCY REPORT – Building Only | | | | | | | |
|---|---|---|---|---|---|---|---|
| 2015 | Potentially Critical | Cooling Generating Systems | Replace | | Floor: Roof 1 Room: Penthouse ID: Type: Cooling Towers | Capital | \$88,425 |

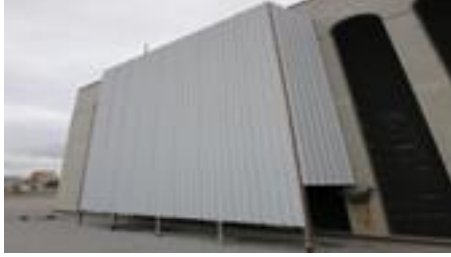
| DEFICIENCY REPORT – Building Only | | | | | | | |
|---|---|---|---|---|---|---|---|
| 2015 | Recommended | Special Structures | Replace | | 1970 System | Capital | \$44,187 |

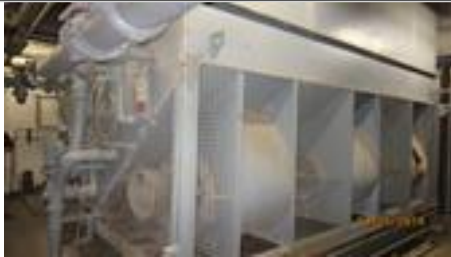
| DEFICIENCY REPORT – Building Only | | | | | | | |
|---|---|---|---|---|---|---|---|
| 2015 | Potentially Critical | Cooling Generating Systems | Replace | | 1970 System | Capital | \$34,174 |

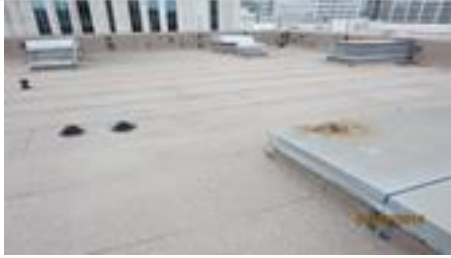
| DEFICIENCY REPORT – Building Only | | | | | | | |
|---|---|---|---|---|---|---|---|
| 2015 | Critical | Roof Coverings | Replace | | Floor: Roof 1 Room: Roof ID: Type: Modified Bitumen | Capital | \$33,713 |

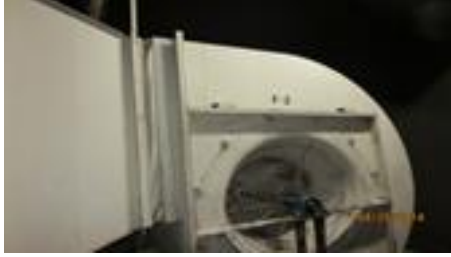
| DEFICIENCY REPORT – Building Only | | | | | | | |
|---|---|---|---|---|---|---|---|
| 2015 | Necessary | Distribution Systems | Replace | | Floor: Roof 1 Room: Penthouse ID: U-696251 Type: Exhaust Fans | Capital | \$23,740 |

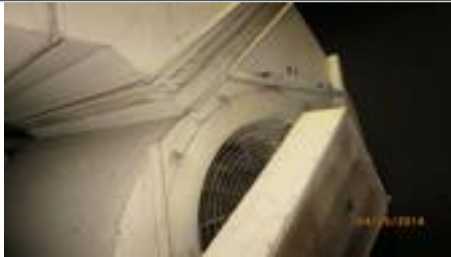
| DEFICIENCY REPORT – Building Only | | | | | | | |
|---|---|---|---|---|---|---|---|
| 2015 | Necessary | Distribution Systems | Replace | | Floor: Roof 1 Room: Penthouse ID: 696252 Type: Exhaust Fans | Capital | \$23,740 |

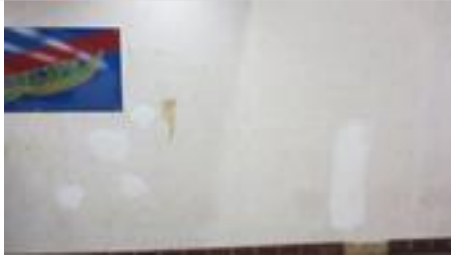
| DEFICIENCY REPORT – Building Only | | | | | | | |
|---|---|---|---|---|---|---|---|
| 2015 | Recommended | Wall Finishes | Remove and Replace | | Floor: 1 Room: Lobby | Maintenance | \$23,640 |

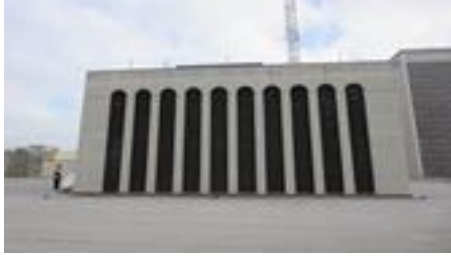
| DEFICIENCY REPORT – Building Only | | | | | | | |
|---|---|---|---|---|---|---|---|
| 2015 | Recommended | Exterior Windows | Renew Finishes | | Floor: Roof 1 Room: Roof | Maintenance | \$22,177 |

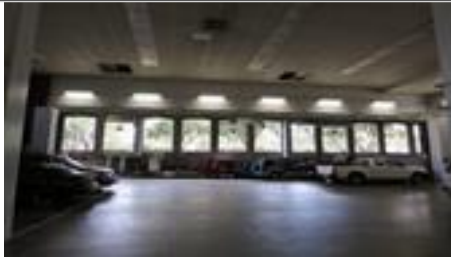
| DEFICIENCY REPORT – Building Only | | | | | | | |
|---|---|---|---|---|--|---|---|
| 2015 | Recommended | Exterior Doors | Remove and Replace | | Floor: 1 Room: Fire Staion | Maintenance | \$21,471 |

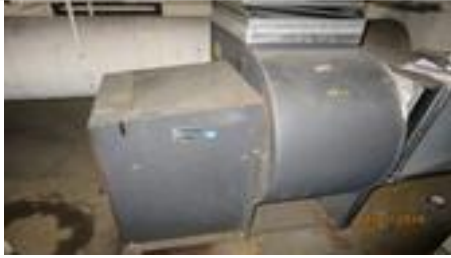
| DEFICIENCY REPORT – Building Only | | | | | | | |
|---|---|---|---|---|--|---|---|
| 2015 | Necessary | Distribution Systems | Replace | | Floor: Roof 1 Room: Penthouse ID: 4UG0298 Type: Exhaust Fans | Capital | \$14,175 |

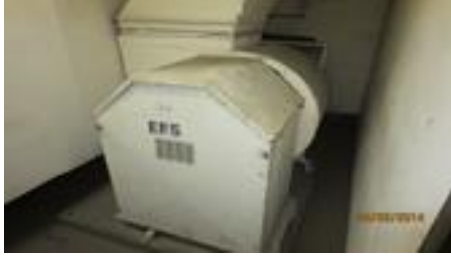
| DEFICIENCY REPORT – Building Only | | | | | | | |
|---|---|---|---|---|--|---|---|
| 2015 | Necessary | Distribution Systems | Replace | | Floor: Roof 1 Room: Penthouse ID: Type: Exhaust Fans | Capital | \$14,175 |

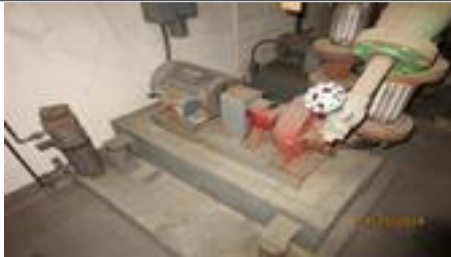
| DEFICIENCY REPORT – Building Only | | | | | | | |
|---|---|---|---|---|---|---|---|
| 2015 | Necessary | Distribution Systems | Replace | | Floor: Roof 1 Room: Penthouse ID: Type: Cooling Tower Water Pumps | Capital | \$12,568 |

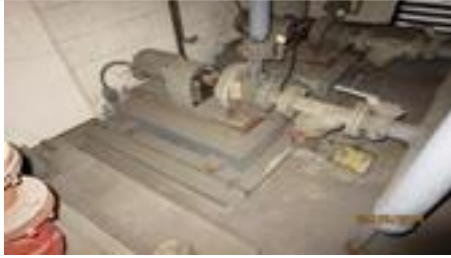
| DEFICIENCY REPORT – Building Only | | | | | | | |
|---|---|---|---|---|---|---|---|
| 2015 | Necessary | Distribution Systems | Replace | | Floor: Roof 1 Room: Penthouse ID: Type: Cooling Tower Water Pumps | Capital | \$12,568 |

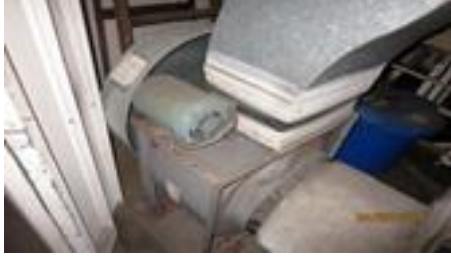
| DEFICIENCY REPORT – Building Only | | | | | | | |
|---|---|---|---|---|---|---|---|
| 2015 | Necessary | Distribution Systems | Replace | | Floor: Roof 1 Room: Penthouse ID: Type: Exhaust Fans | Capital | \$12,025 |

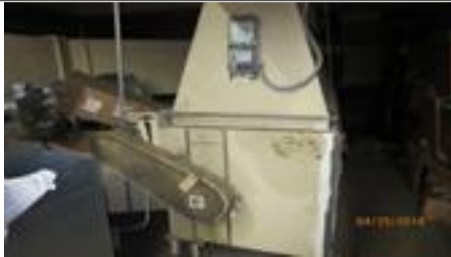
| DEFICIENCY REPORT – Building Only | | | | | | | |
|---|---|---|---|---|--|---|---|
| 2015 | Necessary | Distribution Systems | Replace | | Floor: B1 Room: Mech Room ID: Type: Exhaust Fans | Capital | \$10,144 |

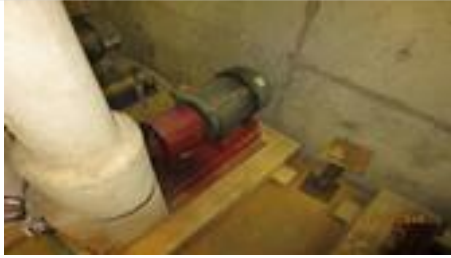
| DEFICIENCY REPORT – Building Only | | | | | | | |
|---|---|---|---|---|--|---|---|
| 2015 | Necessary | Distribution Systems | Replace | | Floor: B1 Room: Mech Room 2 ID: Type: Chilled Water Pumps | Capital | \$9,891 |

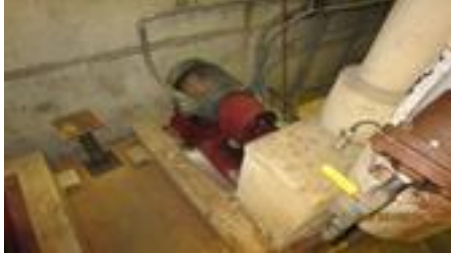
| DEFICIENCY REPORT – Building Only | | | | | | | |
|---|---|---|---|---|--|---|---|
| 2015 | Necessary | Distribution Systems | Replace | | Floor: B1 Room: Mech Room 2 ID: Type: Chilled Water Pumps | Capital | \$9,891 |

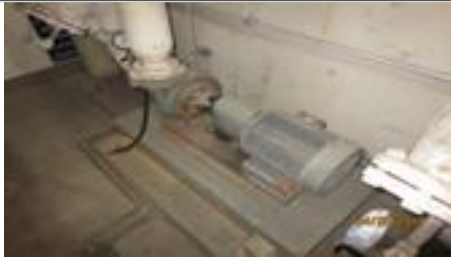
| DEFICIENCY REPORT – Building Only | | | | | | | |
|---|---|---|---|---|---|---|---|
| 2015 | Necessary | Distribution Systems | Replace | | Floor: Roof 1 Room: Penthouse ID: Type: Chilled Water Pumps | Capital | \$9,891 |

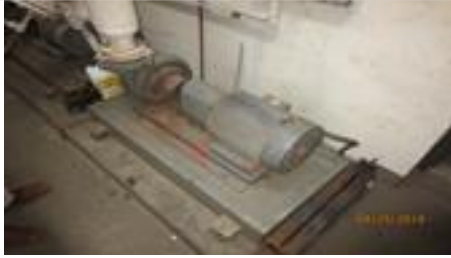
| DEFICIENCY REPORT – Building Only | | | | | | | |
|---|---|---|---|---|---|---|---|
| 2015 | Necessary | Distribution Systems | Replace | | Floor: Roof 1 Room: Penthouse ID: Type: Chilled Water Pumps | Capital | \$9,891 |

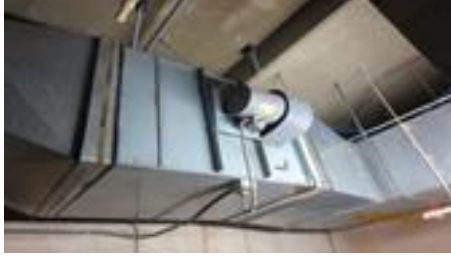
| DEFICIENCY REPORT – Building Only | | | | | | | |
|---|---|---|---|---|---|---|---|
| 2015 | Necessary | Distribution Systems | Replace | | Floor: B1 Room: Basement ID: 191588 Type: Exhaust Fans | Capital | \$9,532 |

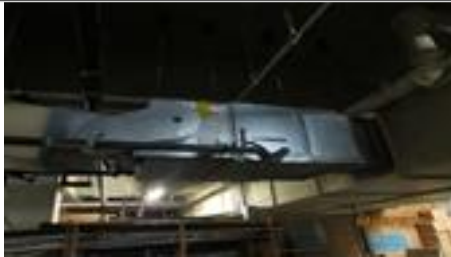
| DEFICIENCY REPORT – Building Only | | | | | | | |
|---|---|---|---|---|--|---|---|
| 2015 | Necessary | Distribution Systems | Replace | | Floor: B1 Room: Basement ID: Type: Fan Coil Units | Capital | \$7,874 |

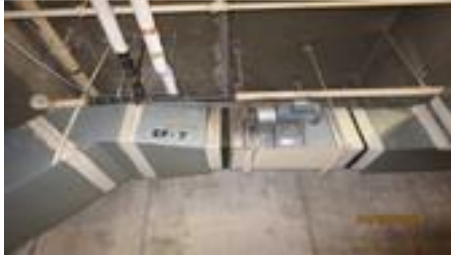
| DEFICIENCY REPORT – Building Only | | | | | | | |
|---|---|---|---|---|--|---|---|
| 2015 | Necessary | Distribution Systems | Replace | | Floor: B1 Room: Basement ID: Type: Exhaust Fans | Capital | \$7,798 |

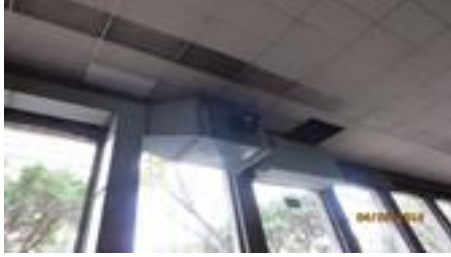
| DEFICIENCY REPORT – Building Only | | | | | | | |
|---|---|---|---|---|--|---|---|
| 2015 | Necessary | Distribution Systems | Replace | | Floor: 1 Room: Fire Station Bay ID: Type: Exhaust Fans | Capital | \$7,798 |

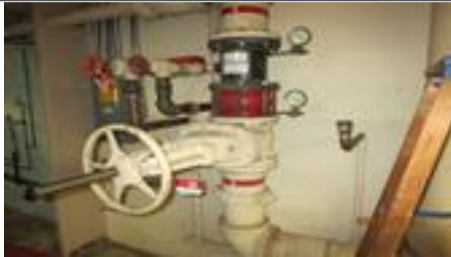
| DEFICIENCY REPORT – Building Only | | | | | | | |
|---|---|---|---|---|--|---|---|
| 2015 | Critical | Sprinklers | Replace | | Floor: B1 Room: Basement ID: Type: Fire Suppression Valve | Capital | \$7,039 |

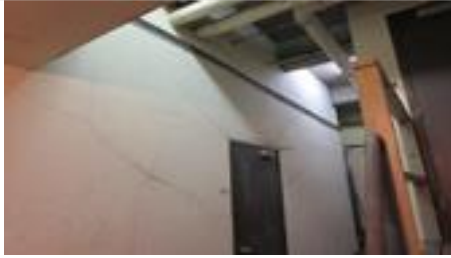
| DEFICIENCY REPORT – Building Only | | | | | | | |
|---|---|---|---|---|--|---|---|
| 2015 | Recommended | Wall Finishes | Repair | | Floor: 6 Room: Mechanical Penthouse | Maintenance | \$6,504 |

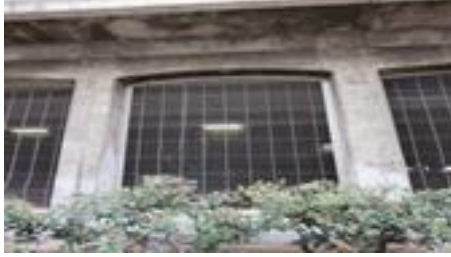
| DEFICIENCY REPORT – Building Only | | | | | | | |
|---|---|---|---|---|--|---|---|
| 2015 | Recommended | Exterior Windows | Renew Finishes | | Floor: 1 Room: Fire Staion | Maintenance | \$5,795 |

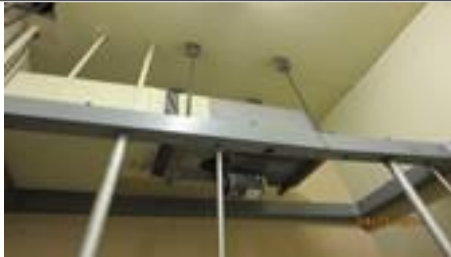
| DEFICIENCY REPORT – Building Only | | | | | | | |
|---|---|---|---|---|--|---|---|
| 2015 | Necessary | Distribution Systems | Replace | | Floor: 5 Room: Phone Room ID: 152857 Type: Exhaust Fans | Capital | \$5,496 |

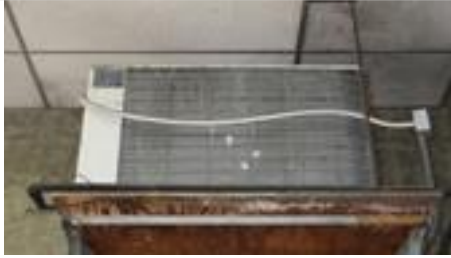
| DEFICIENCY REPORT – Building Only | | | | | | | |
|---|---|---|---|---|--|---|---|
| 2015 | Potentially Critical | Terminal and Package Units | Replace | | Floor: 1 Room: Loading Dock ID: Type: Air Cooled Condensing Units | Capital | \$4,448 |

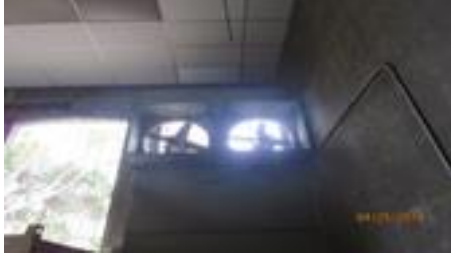
| DEFICIENCY REPORT – Building Only | | | | | | | |
|---|---|---|---|---|--|---|---|
| 2015 | Necessary | Distribution Systems | Replace | | Floor: 1 Room: Fire Station Bay ID: Type: Exhaust Fans | Capital | \$3,549 |

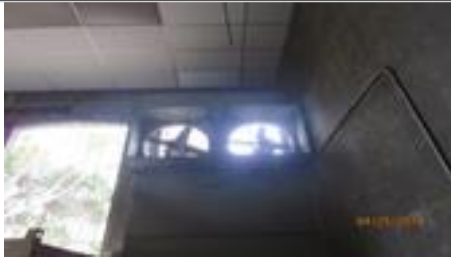
| DEFICIENCY REPORT – Building Only | | | | | | | |
|---|---|---|---|---|---|---|---|
| 2015 | Necessary | Distribution Systems | Replace | | Floor: 1 Room: Fire Station Bay ID: Type: Exhaust Fans | Capital | \$3,549 |

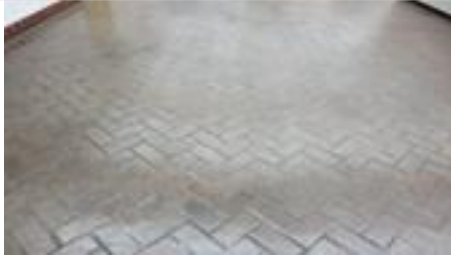
| DEFICIENCY REPORT – Building Only | | | | | | | |
|---|---|---|---|---|---|---|---|
| 2015 | Recommended | Floor Finishes | Clean | | Floor: 1 Room: Lobby | Maintenance | \$1,368 |

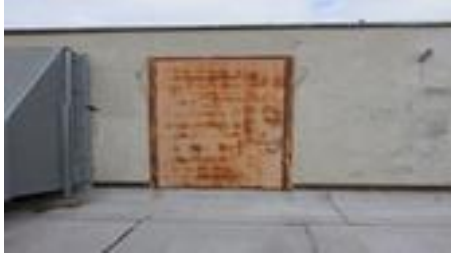
| DEFICIENCY REPORT – Building Only | | | | | | | |
|---|---|---|---|---|---|---|---|
| 2015 | Recommended | Exterior Doors | Renew Finishes | | Floor: Roof 1 Room: Roof | Maintenance | \$1,127 |

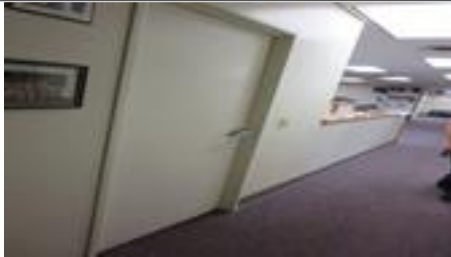
| DEFICIENCY REPORT – Building Only | | | | | | | |
|---|---|---|---|---|---|---|---|
| 2015 | Necessary | Interior Doors | Repair | | Floor: 1 Room: Fire Station Offices | Maintenance | \$314 |

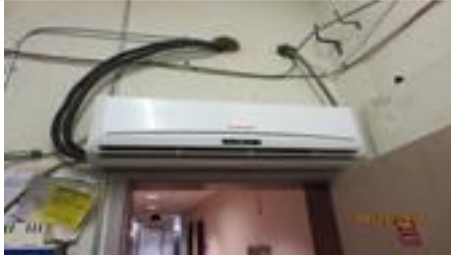
| DEFICIENCY REPORT – Building Only | | | | | | | |
|---|---|---|---|---|---|---|---|
| 2017 | Necessary | Distribution Systems | Replace | | Floor: 5 Room: Data Room ID: Type: Fan Coil Units | Capital | \$5,350 |

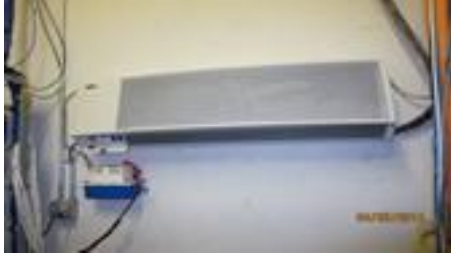
| DEFICIENCY REPORT – Building Only | | | | | | | |
|---|---|---|---|---|---|---|---|
| 2017 | Necessary | Distribution Systems | Replace | | Floor: 5 Room: Data Room ID: Type: Fan Coil Units | Capital | \$5,350 |

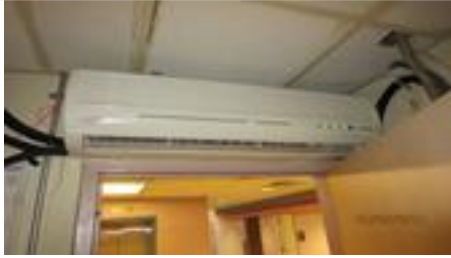
| DEFICIENCY REPORT – Building Only | | | | | | | |
|---|---|---|---|---|---|---|---|
| 2017 | Necessary | Distribution Systems | Replace | | Floor: 5 Room: Data Room ID: Type: Fan Coil Units | Capital | \$4,891 |

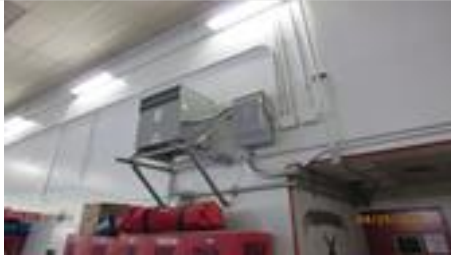
| DEFICIENCY REPORT – Building Only | | | | | | | |
|---|---|---|---|---|---|---|---|
| 2020 | Potentially Critical | Terminal and Package Units | Replace | | 1970 System | Capital | \$684,060 |

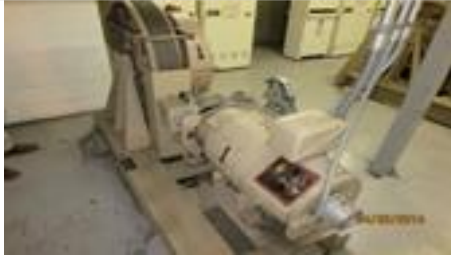
| DEFICIENCY REPORT – Building Only | | | | | | | |
|---|---|---|---|---|---|---|---|
| 2020 | Necessary | Elevators and Lifts | Replace | | Floor: Roof 1 Room: Elevator Machine Room ID: 2-40152-57 Type: Elevators | Capital | \$421,156 |

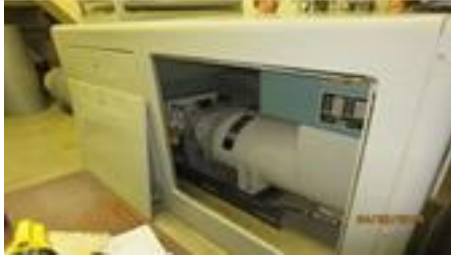
| DEFICIENCY REPORT – Building Only | | | | | | | |
|---|---|---|---|---|---|---|---|
| 2020 | Critical | Other Electrical or Generator | Replace | | Floor: B1 Room: Generator Room ID: S423331 Type: Generators | Capital | \$146,289 |

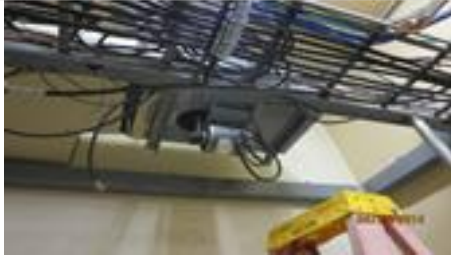
| DEFICIENCY REPORT – Building Only | | | | | | | |
|---|---|---|---|---|---|---|---|
| 2020 | Necessary | Distribution Systems | Replace | | Floor: 5 Room: Data Room ID: 152856 Type: Exhaust Fans | Capital | \$5,994 |

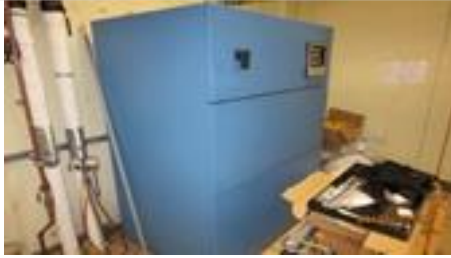
| DEFICIENCY REPORT – Building Only | | | | | | | |
|---|---|---|---|---|--|---|---|
| 2025 | Necessary | Distribution Systems | Replace | | Floor: B1 Room: Data Room 2 ID: Type: Air Handling Units | Capital | \$65,587 |

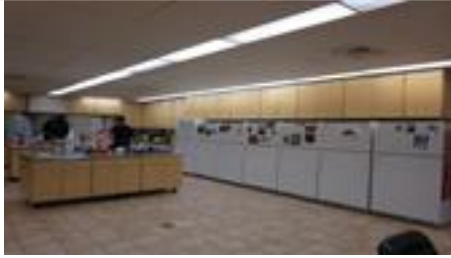
| DEFICIENCY REPORT – Building Only | | | | | | | |
|---|---|---|---|---|--|---|---|
| 2029 | Recommended | Other Equipment | Replace | | 1970 System | Capital | \$639,725 |

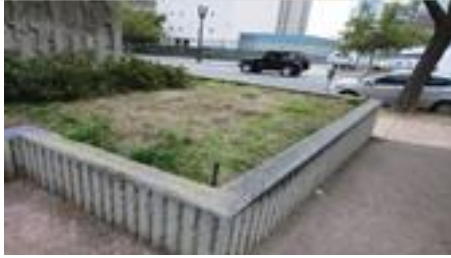
| DEFICIENCY REPORT – Site Only | | | | | | | |
|---|---|---|---|---|---|---|---|
| 2015 | Recommended | Landscaping | Replace | | 1970 System | Capital | \$82,279 |
